CMOP June 2022 Update: Placed over 1,600m³ of concrete for the ball mill and scrubber area

LIMA – July 7, 2022 – Boroo Pte. Ltd (“Boroo” or the “Company”) is pleased to provide a project update for the fast-track Lagunas Norte Carbonaceous Material Optimization Project (CMOP) in Peru for June 2022.

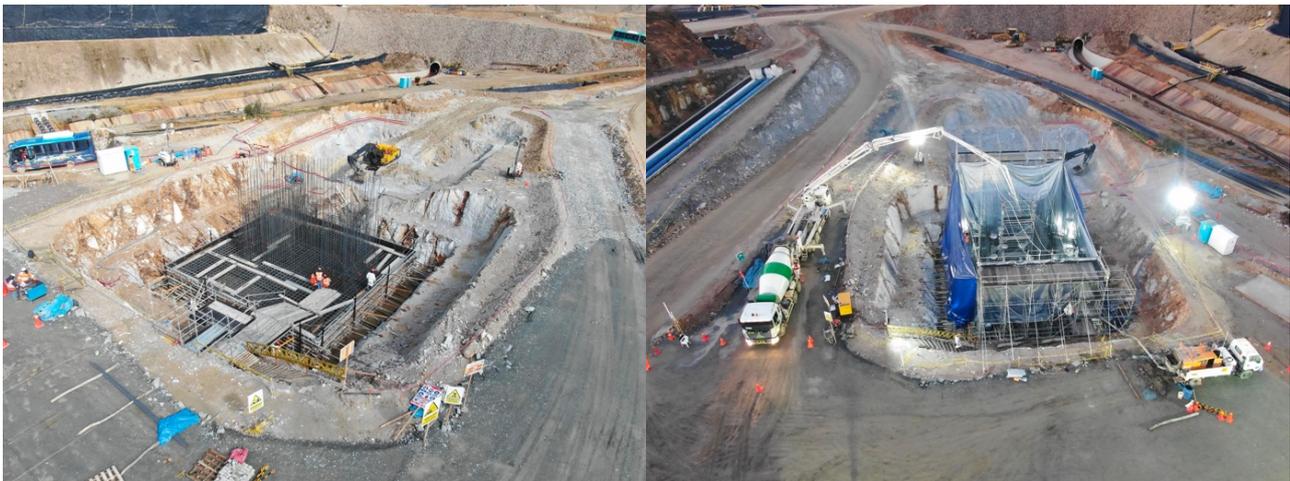
Figure 1. Shows the Ball Mill foundation that contains approximately 400m³ of concrete. All the placement of concrete occurred on night shift in a temperature-controlled environment with WSP Golder QA/QC personnel monitoring key quality metrics.

In addition to having Zero lost time incidents on the project to-date, the QA/QC has been closely monitored by WSP Golder, the design engineers. Concrete quality has been excellent with all concrete well within the design specification. This project continues to achieve safe production and demonstrates the value of the Safe by Design project philosophy.

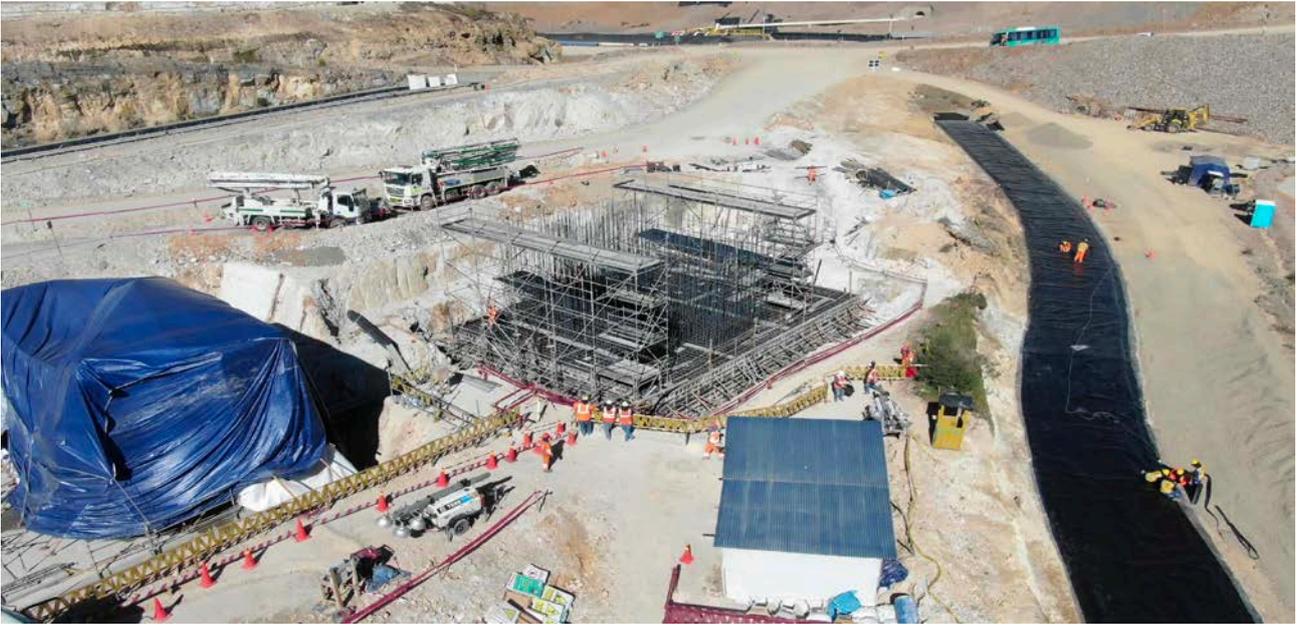
Figure 2. The Scrubber foundation containing over 600m³ of concrete. In the right side of the photo shows some of the work required to protect existing infrastructure.

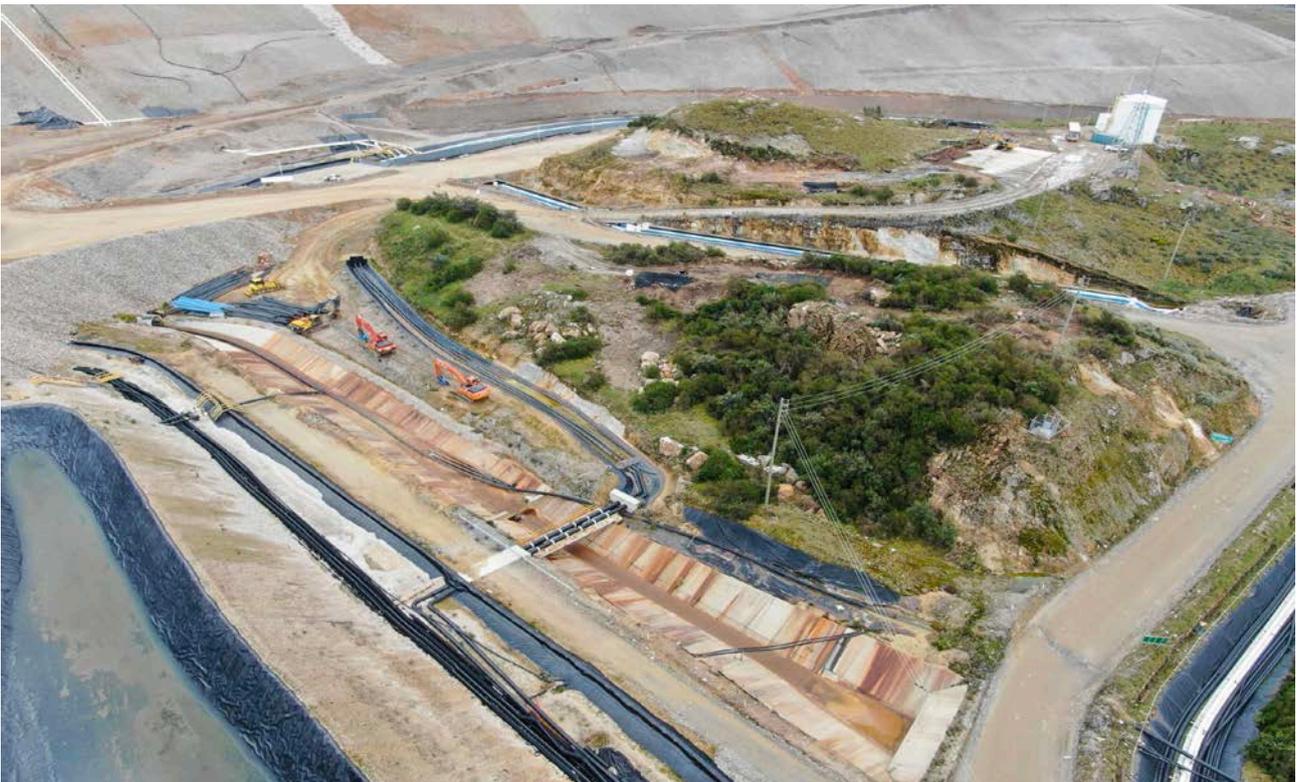
Figure 3 shows the CCS area prior to excavation. The location of the plant had several constraints due to existing infrastructure that had to be mitigated prior to and during the excavation work. All the work was completed without any interruptions to the operation.

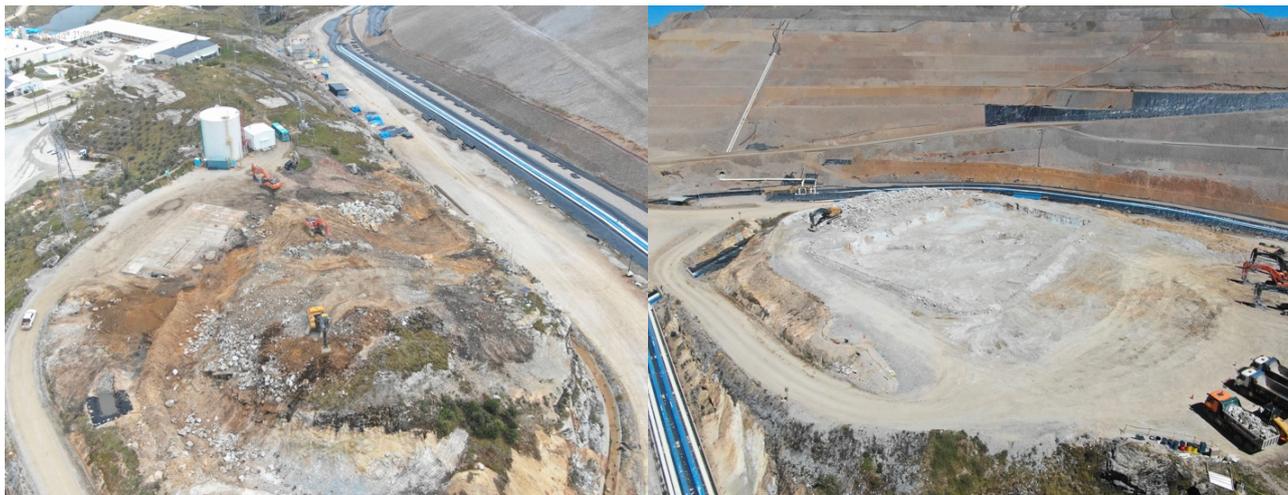
Figure 4. The photo on the left shows the Tailings filtration area in the early stages of exaction. The photo on the right shows the finished platform after the removal of approximately 125,000 m³ of hard rock material.

The excavation has been completed for the Tailings filtration area that will consist of six Metso 2040 VPA filters. The concrete for the foundations will start in early July with the installation of the structural steel to begin in early August, including the construction of the filter feed tanks. The area excavation was very challenging due to not being able to blast the rock. All the work was done under the close Supervision of the Boroo Construction team using community contractors and was completed Safely and within planned schedule. Most of the major filter mechanical components are procured and at Boroo's storage facility in Trujillo, Peru. The plan is to start moving major components to site in early August for installation in conjunction with supporting steel structures.
